SUBJECT: Resubmittal - Enforcement Action against Maui Snorkel Charters, Inc.
for Damaging Coral within the Molokini Shoal Marine Life
Conservation District

'Kai Anela' Investigative Report

RESULTS OF FIELD INVESTIGATION

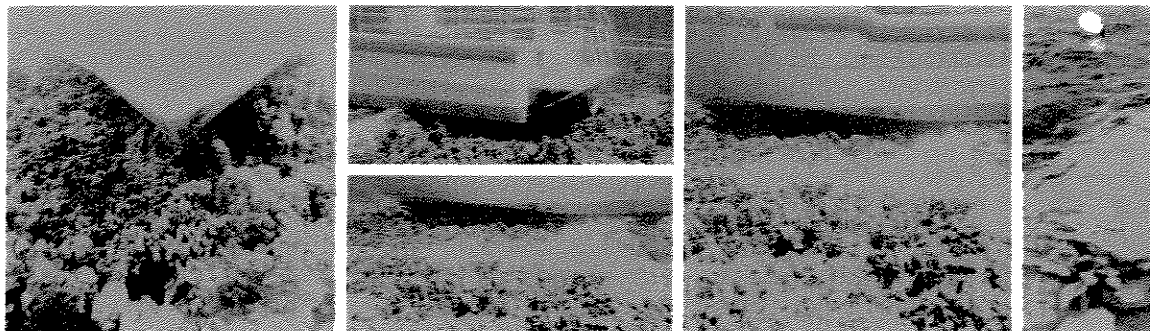
Various views of the 'Kai Anela' atop live coral at Molokini MLCD

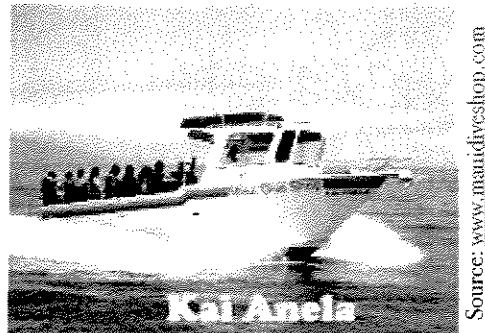
The 'Kai Anela' is a 32' foot long, twin-engine jet-driven, aluminum-hulled vessel. It can carry up to 24 snorkelers plus crew and has a marine head aboard. The owner, Maui Dive Shop, uses the vessel at Molokini MLCD under a permit from the Department.

Fig. 1. 'Kai Anela' Vessel in Use.

On September 29, 2006, at about 12:17 p.m., the master of the charter marine snorkel tour vessel 'Kai Anela' (Figure 1) made a Mayday call reporting his boat was sinking and that he needed immediate assistance. The motor vessel 'Pineapple Express' was already in the area, so the master diverted from his course to assist the 'Kai Anela'. The 'Pineapple Express' arrived on scene before the U.S. Coast Guard, and safely transferred all 15 people from the sinking boat onto the passenger vessel. A Coast Guard rescue boat and crew arrived on scene shortly after. No injuries were reported at the time regarding any passengers or crew. The Coast Guard small boat crew on-scene confirmed that the 'Kai Anela' completely sank and there was no fuel sheen. The Coast Guard established a 100-yard safety zone around the last known position of the vessel. A notice to mariners was broadcast on VHF-FM Channel 16 to alert mariners to the potential hazard to navigation.

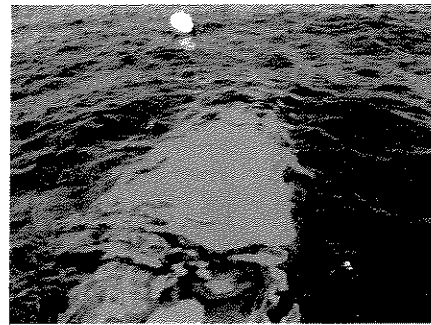
Fig. 2. 'Sunken Kai Anela' Vessel Visible From the Surface.

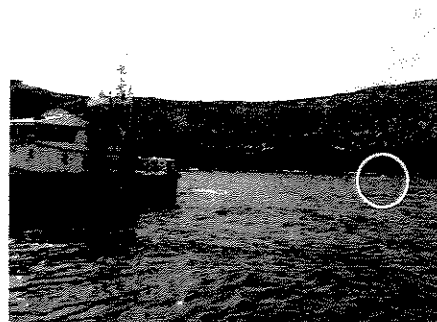
Fig. 3. USCG vessel on-site maintaining safety zone around sunken vessel (location shown with yellow circle).

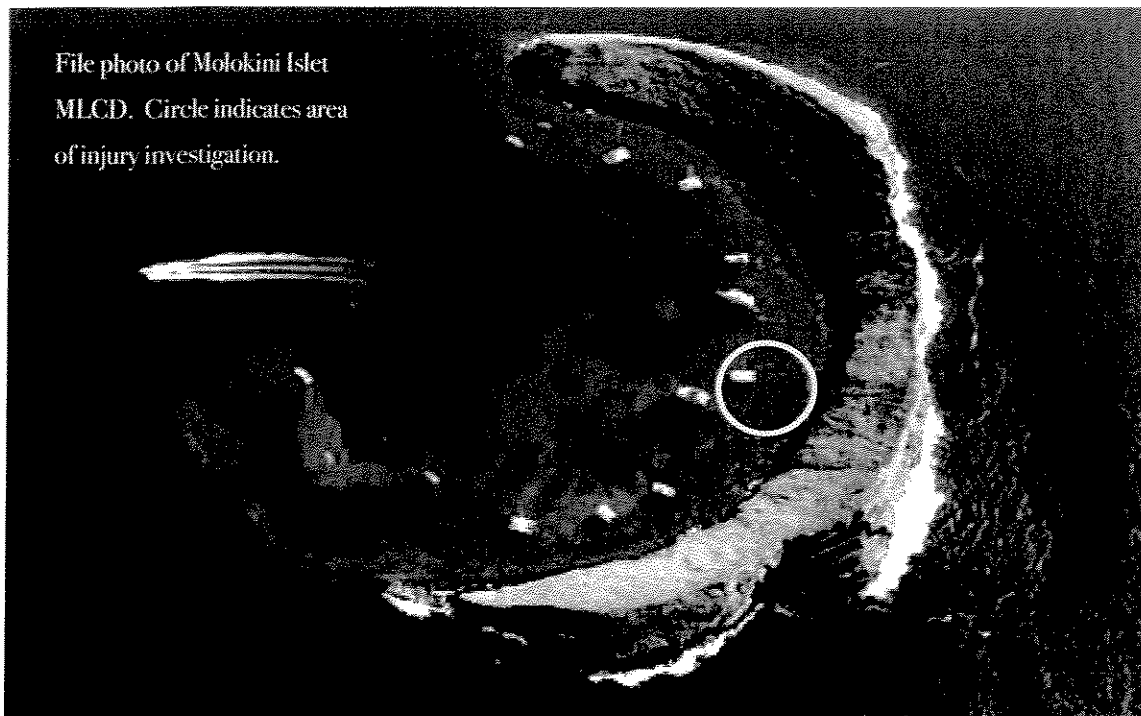
Fig. 4. Molokini MLCD. Yellow circle represents approximate location of the five documented impact areas.

The waters surrounding Molokini Islet are a no-take Marine Life Conservation District (Figure 4). Molokini Islet is located approximately 3 miles off the southwestern coast of Maui. MLCD regulations expressly prohibit injuring of any marine life, and the altering of any geological feature. Rules also require a permit for commercial activities and prohibit the anchoring of boats. The MLCD is divided into two subzones, "A" and "B". Subzone "A" includes the waters within the remnant crater, while subzone "B" surrounds the periphery of the islet.

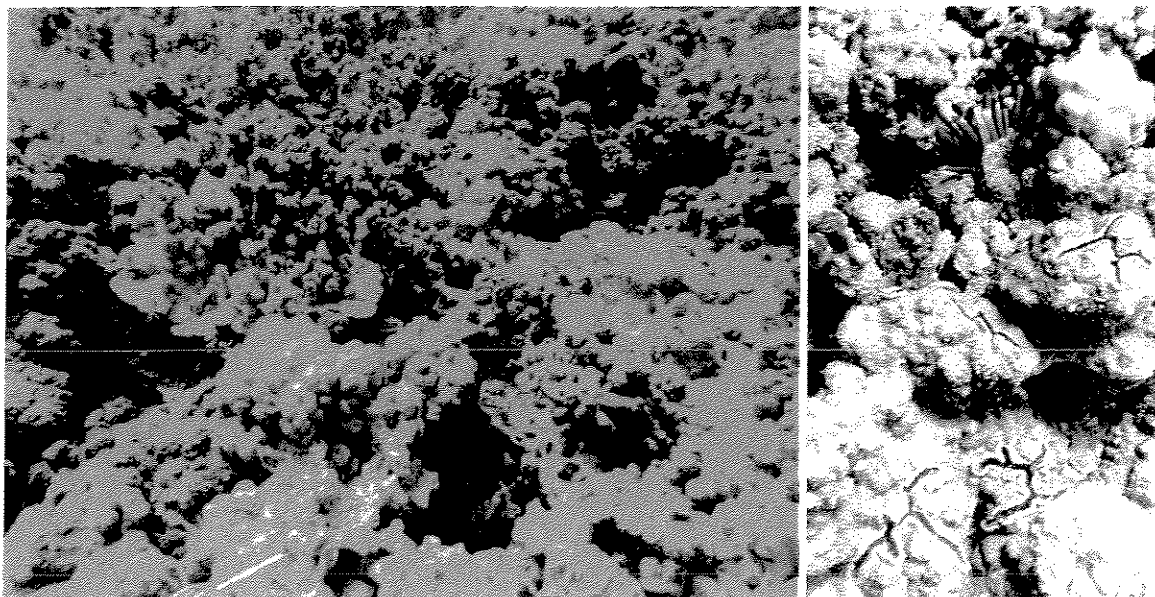
Fig. 5. Area immediately adjacent to injury showing extremely high live coral coverage.

some of the highest live coral cover found at Molokini MLCD (within this depth range) prior to this event (Figure 5). The area was characterized as having well-established colonies of mostly *Porites lobata*, *Montipora capitata*, and *M. patula* forming areas of between 50 - 90% live coral cover.

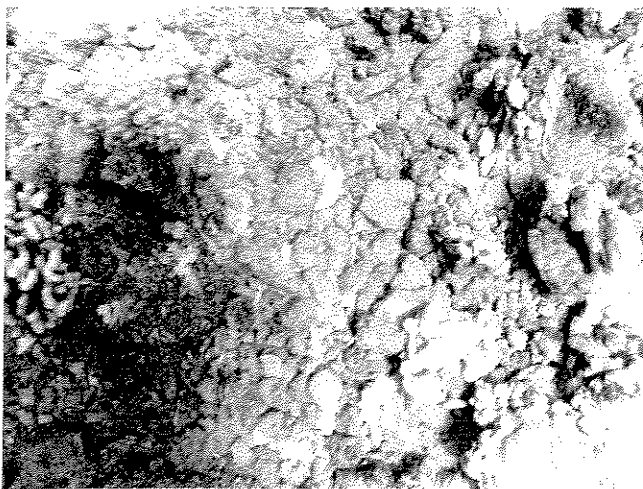
Fig. 9. Large live colonies of coral (>40 cm) were split open (right).

Fig. 8. Large pieces of coral reef substrate were broken into rubble by the initial sinking event (left). Crushed and broken coral was found throughout the measured injury area as shown with flash photography.

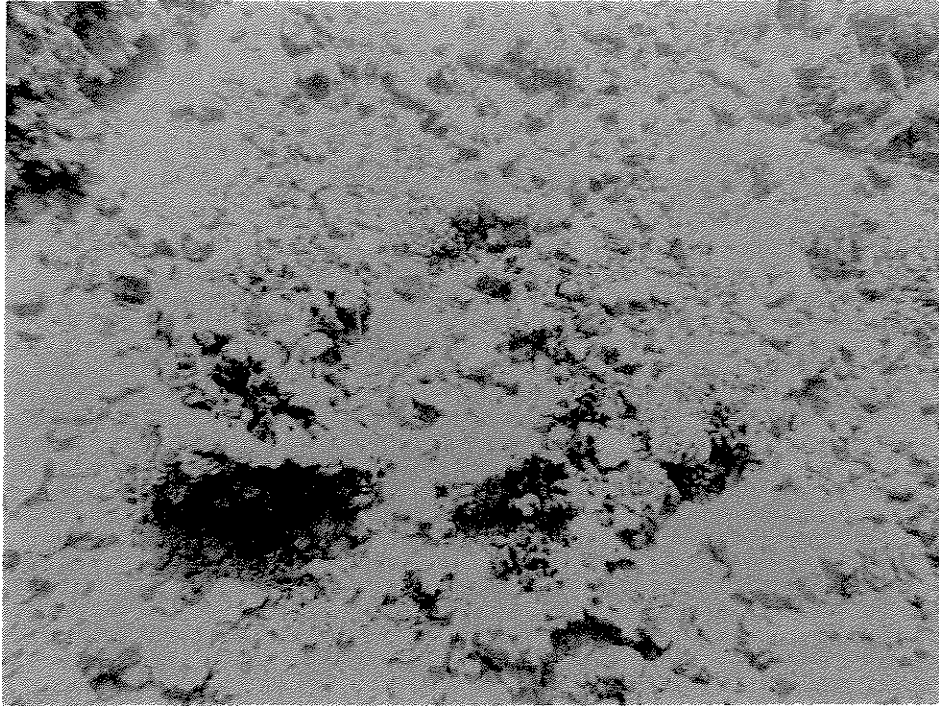
Fig. 10. Rubble, Broken and Over-turned Coral Within Initial Impact Area..

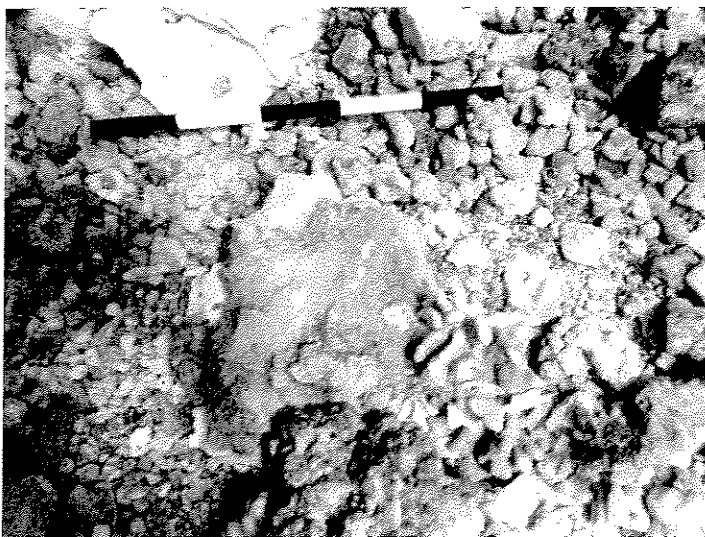
- 2 A **debris field** was measured directly west of the initial impact site and consisted of some minor coral damage and loose paper product fragments in a roughly rectangular-shaped area. Coral and live rock damage was measured based upon the direct injury scar area of 12.25 m length by 7 m width and totaled **85.75 m²**. The damaged area could be characterized as consisting of coral rubble pieces (Figure 11) and loose papers fragments, gauze pads and some loose plastic pieces..

Fig. 11. Rubble and recently broken corals piled within the Debris Field.

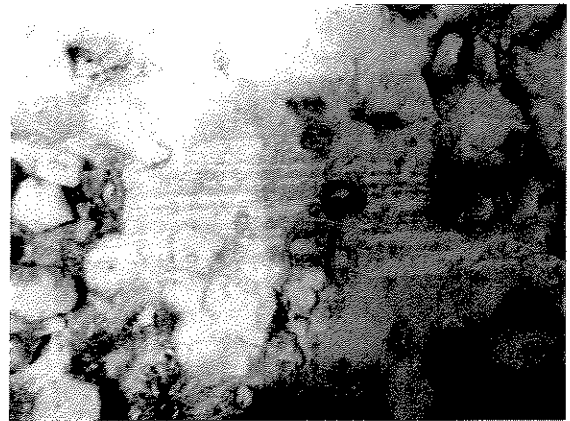
Vessel Dragging Scar Site: Located at W 20° 63141, N 156° 49656. Extending from the initial impact site to the secondary impact site. Large amount of broken coral and some overturned coral heads in approximately 20' depth. Collected samples of both paint scrapings and metal scrapings on freshly broken coral (as evidenced by the bright white internal exposed skeleton, live coral tissue and lack of wear or overgrowth by algae on the broken coral pieces). Coral and live rock damage was measured based upon the direct injury scar area of 7 m length by 1.7 m width and totaled **11.9 m²**. The damaged area could be characterized as consisting of shattered, dislodged heads of coral (Figures 12 & 13).

Fig. 12. Scrapes in broken coral colonies show direction of the vessel being dragged through the living reef substrate.

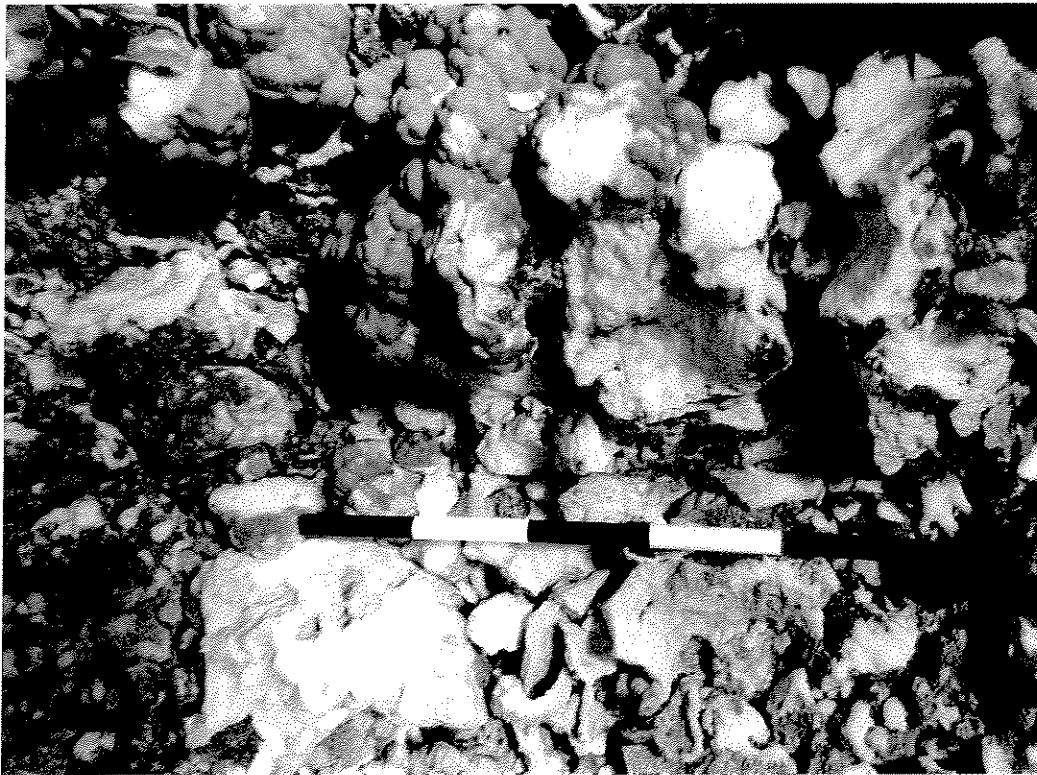
Fig. 13. Breakage occurred in large (>50 cm diameter) colonies of coral that may represent colonies over 50 years old.

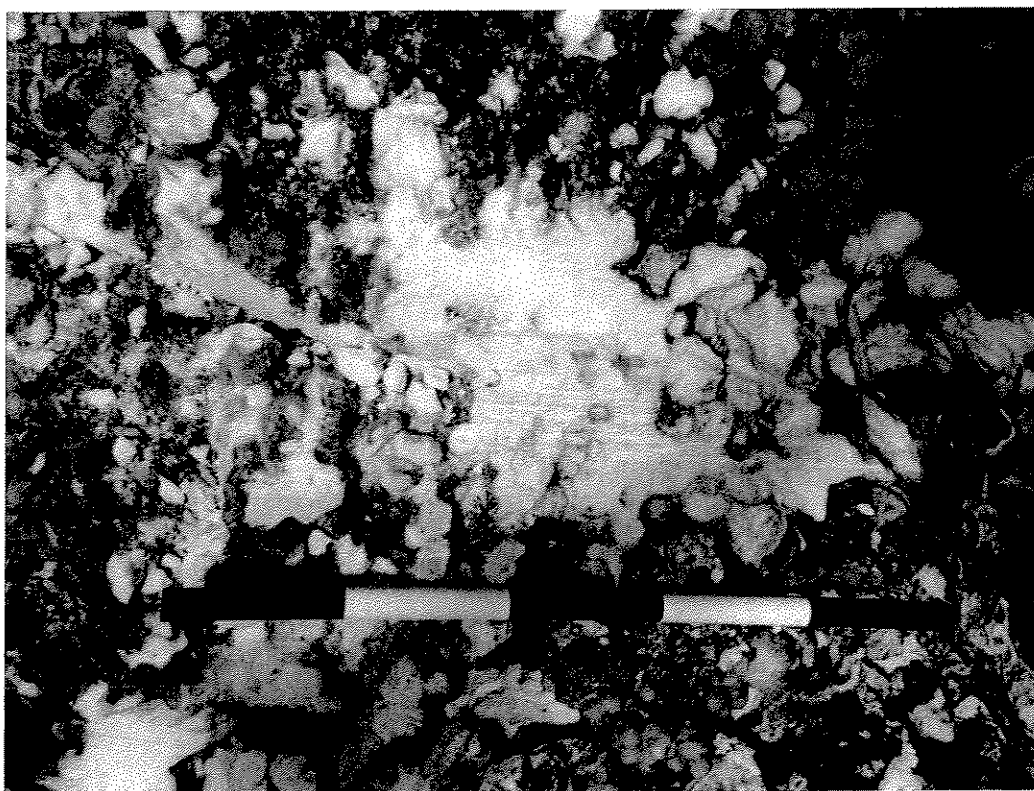
Fig. 14. Fractured coral colony showing hull scrape caused as vessel was dragged through the reef to move it.

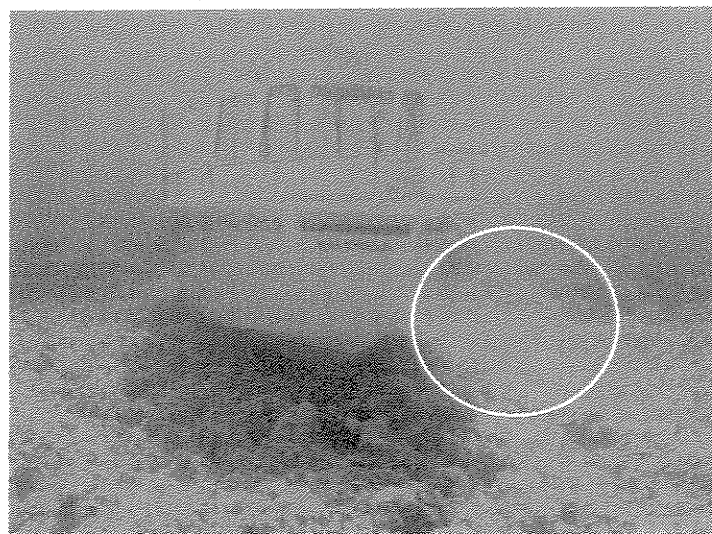
Secondary Impact Site: Located at W 20° 63145, N 156° 49651. Similar in shape and size to the first impact site (roughly the length of the bottom portion of the submerged vessel sitting directly to the east of it (Figure 15). High amount of smashed and broken live coral; some pulverization in approximately 25' depth (Figures 16 through 19). Collected samples freshly broken coral (as evidenced by the bright white internal exposed skeleton, live coral tissue and lack of wear or overgrowth by algae on the broken coral pieces) with metal scrapings on it. Coral and live rock damage was measured based upon the direct injury scar area of 10.02 m length by 4.3 m width and totaled **43.09 m²**. The damaged area could be characterized as consisting of broken and severely crushed coral.

Fig. 15. The Secondary Impact Site was located to the west of the vessel's submerged location. It represented the location where the vessel was dragged to. The lack of marks between the Secondary and Tertiary Impact Sites suggests that the vessel was raised and then re-sunk in its position shown.

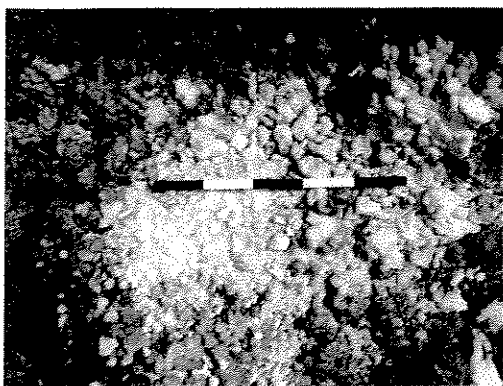
Fig. 16. Shattered coral colonies (scale bar is 50 cm long in 10 cm segments).

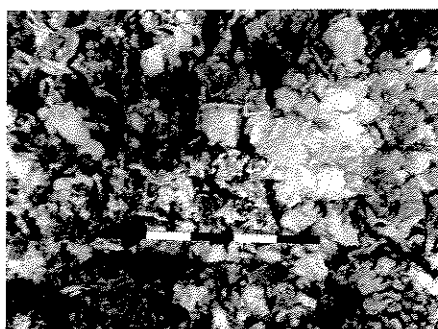
Fig. 18. Shattered coral colonies, including close-up of internal skeleton rubble.

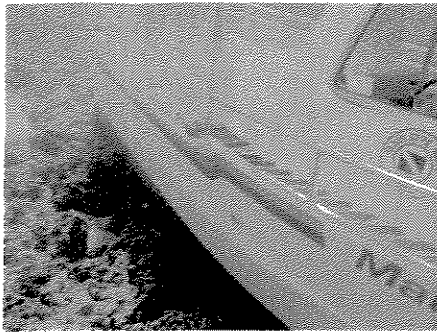
Fig. 21. Submerged vessel lying directly atop living coral (*above and right*). Broken coral next to keel (*below*).

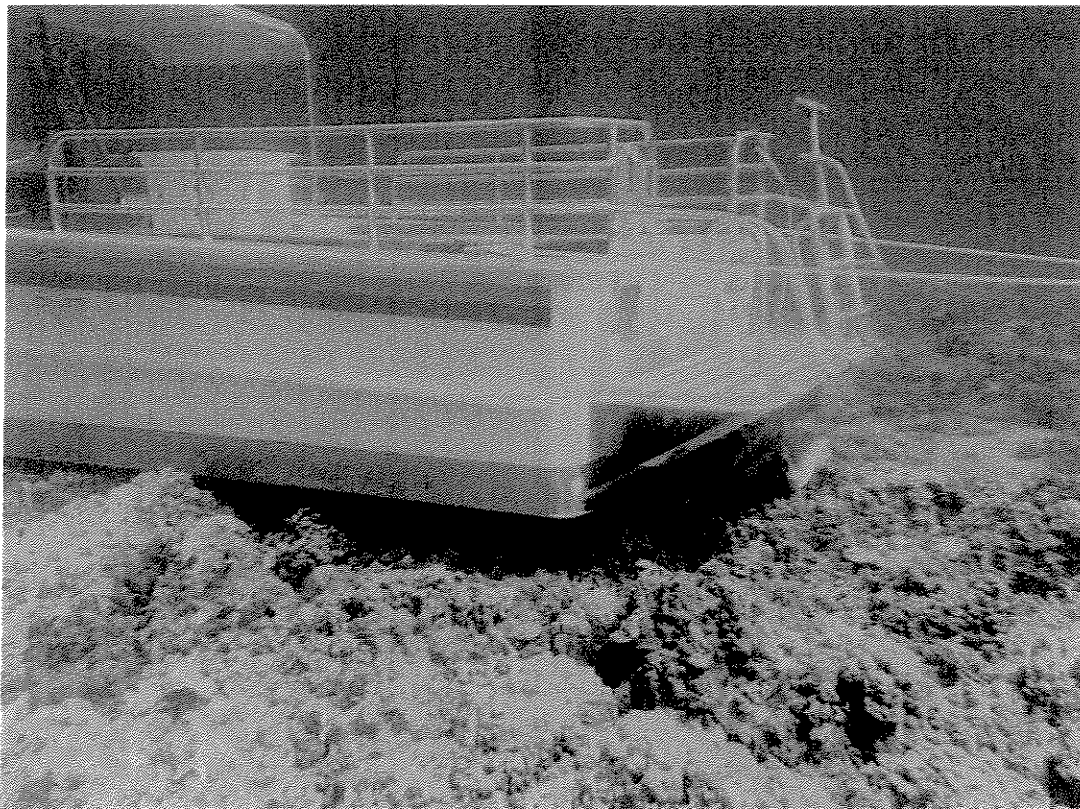
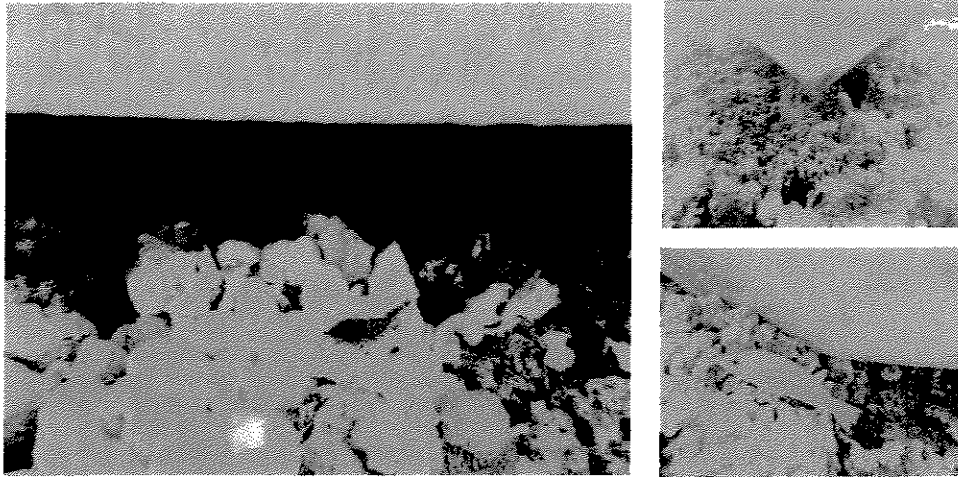
Fig. 23. Various parts of the hull lying atop broken and crushed coral (*above* and *below*).

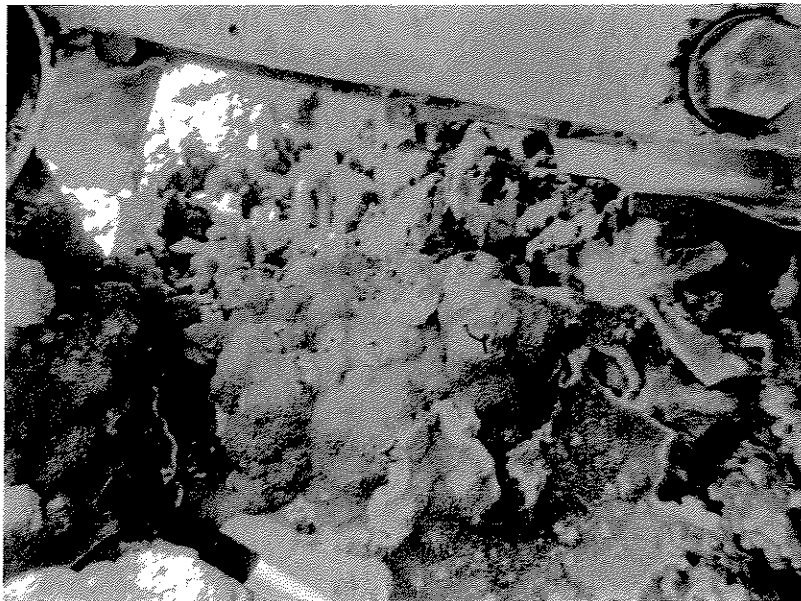
Fig. 24. Portions of the hull lying directly atop live coral (*left*).

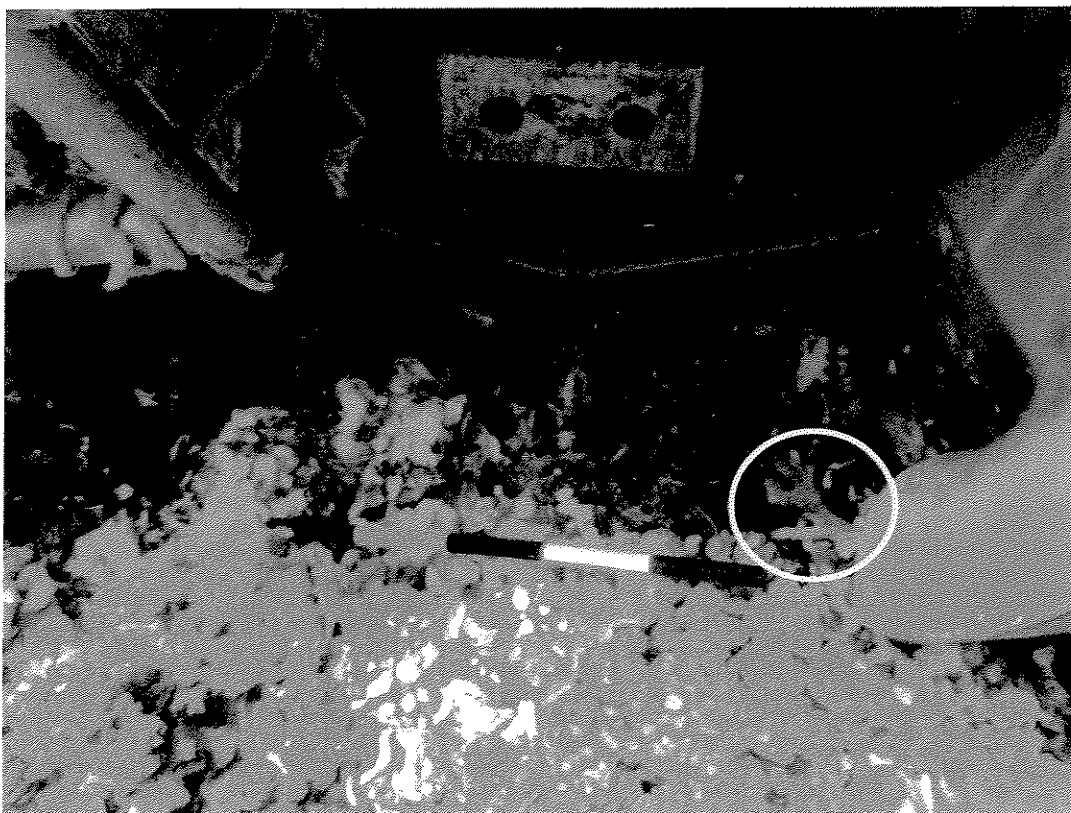
Fig. 25. Hull near one of the thruster ports. Note the large broken branch tip of a large *Pocillopora eydouxi* colony (yellow circle); intact large colonies of this species are used by a variety of fish and invertebrates as shelter habitat.

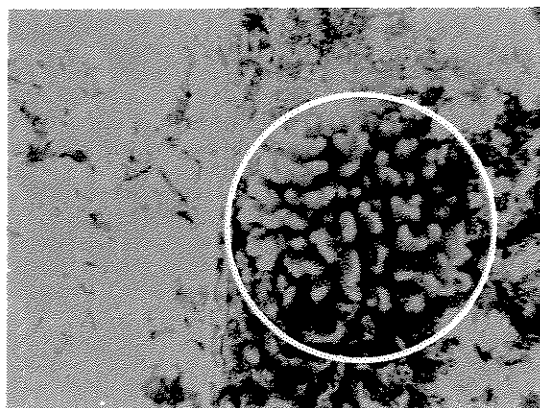
- 6 Some **anchor chain damage** to coral heads from lateral movement of the vessel's deployed anchor chain in approximately 30 – 35' depth. Measured 11.06 m of deployed chain connected to an anchor which was atop the bottom at 38' depth. Figure 26 shows a portion of the anchor chain atop the marine substrate and adjacent to a large *Pocillopora* colony. Note the bright white skeleton on the branch tips, possibly the result of the chain abrading the large coral colony as it moves about the bottom.

Fig. 26. The deployment of the anchor and chain constitute additional damage not formally measured but also may represent an additional violation through its use if not authorized.

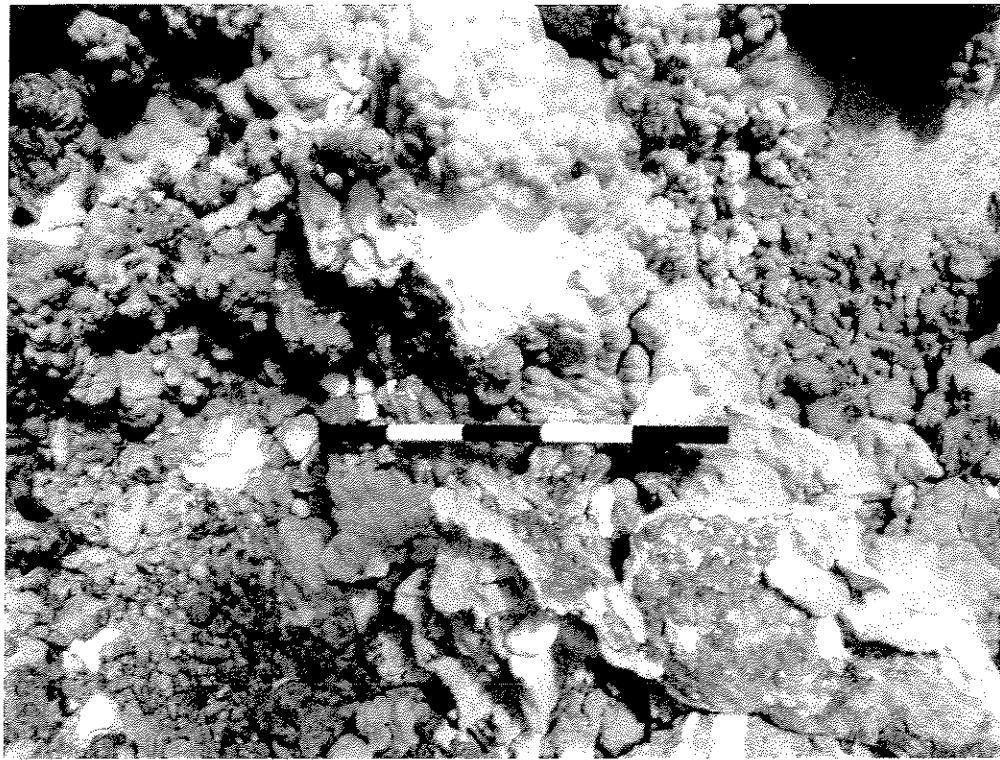
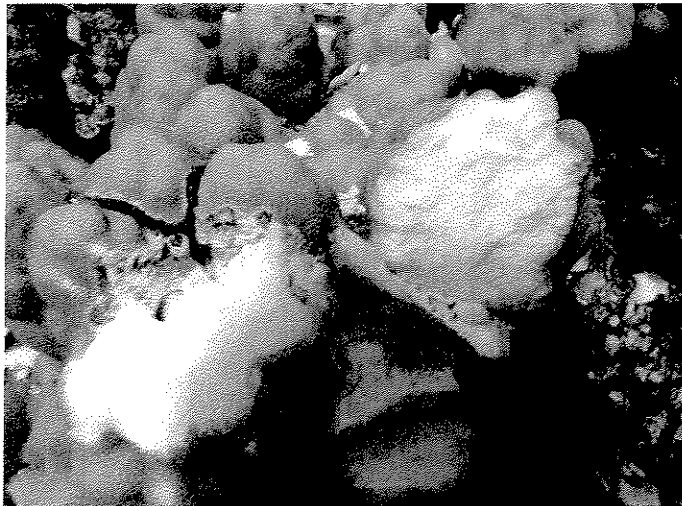
Fig. 27. Examples of fresh coral damage (*above and left*) from the 'Kai Anela' injury as evidenced by bright white skeleton with no wear or organism overgrowth. Contrast against older exposed sections and living coral

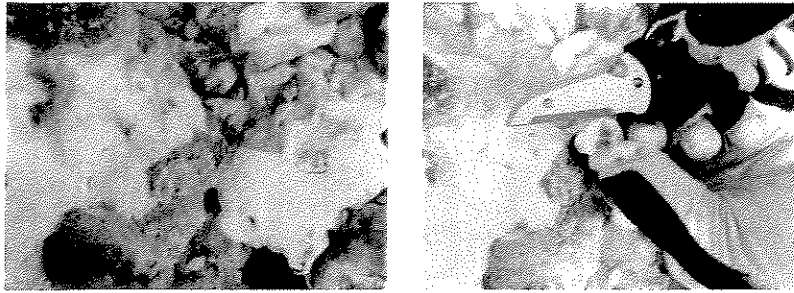
(A) Aluminum scrape on smashed coral (Figure 28) was collected from the Vessel Dragging

Fig. 28. Photos show in situ shot and collection of evidence underwater.

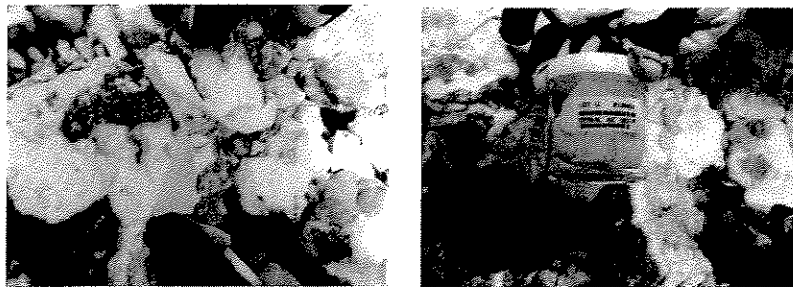
(B₁) Loose paint flakes found on the marine substrate within the Secondary Impact Site (4).

Fig. 29. Photos show in situ shot, and collection of paint flake evidence underwater.

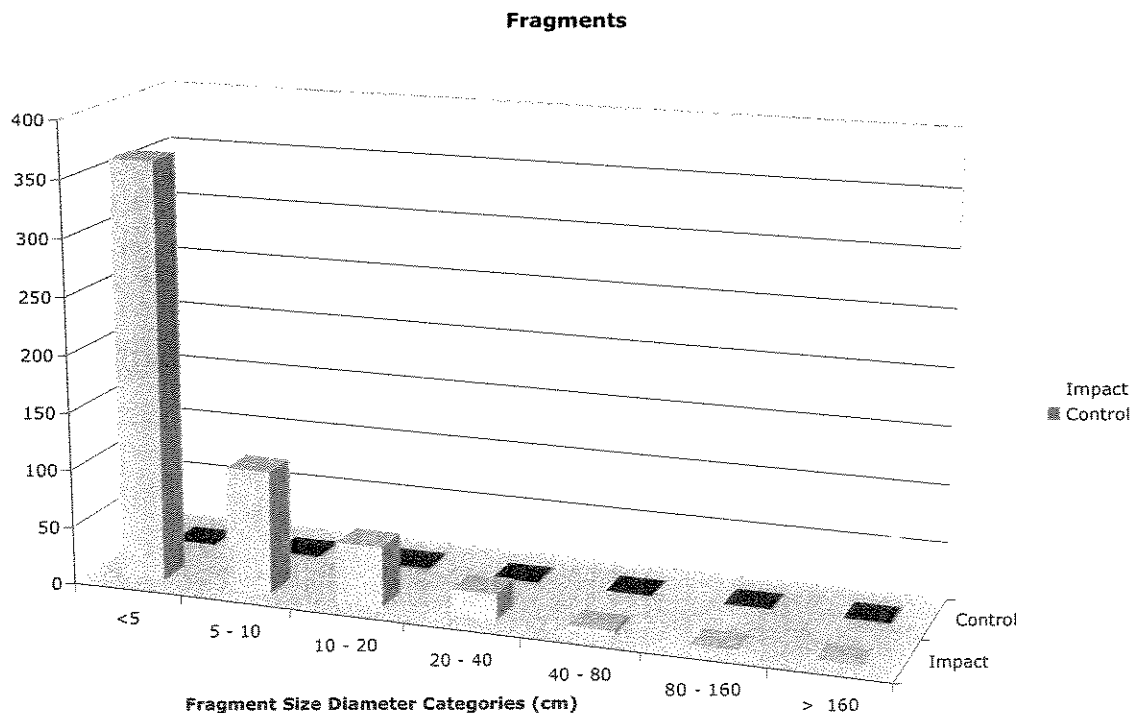
Concerns regarding pre-existing damage to reef substrate resources (versus that caused by the RP) were measured by comparison of loose coral fragments within each of the impact areas versus the twelve control transects conducted immediately adjacent to the documented impact areas (Figure 32). The extremely large number of fragments found within impact areas (labeled 'Impact') versus the almost complete lack of fragments found adjacent to these areas (labeled 'Control') suggests that the reef substrate was relatively intact immediately prior to this incident, and therefore the damage noted was due to this series of incidents by the RP.

Fig. 32. Comparison of loose coral fragments documented within all impact areas (5) versus all control areas (12).

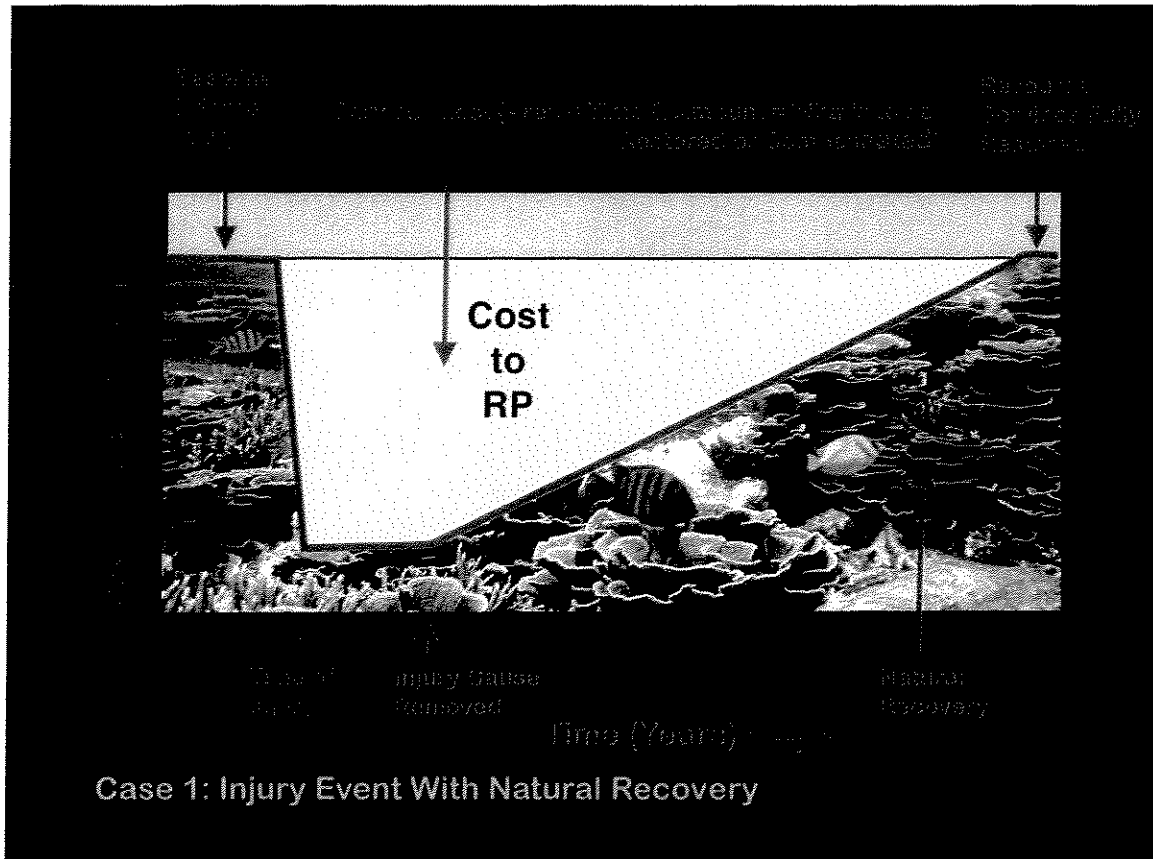
Fig. 34. Generalized representation of recovery elements involved in reef injuries such as those caused by the 'Kai Anela' incident (after Gulko *et al*, 2007).

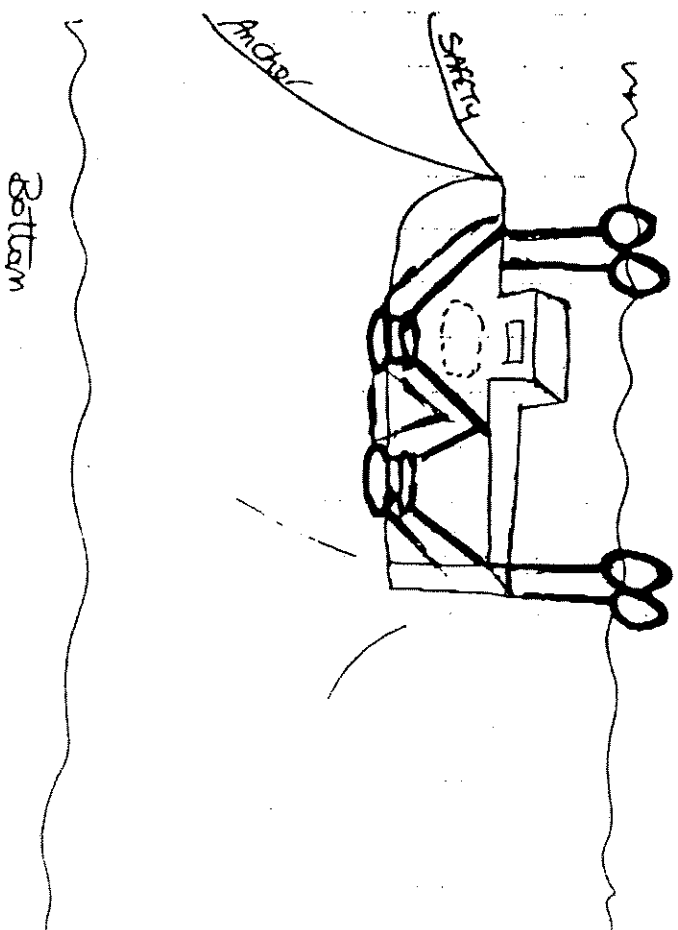
Step #2 (Extra Lift)

- 1. Vessel 15,000 lbs
- 2. Lift Bags - $4 \times 2000 = 8000 \text{ lbs}$
